# INSTRUCTIONS FOR CONTINUED AIRWORTHINESS

GAS BALLOON  
MODEL NL - STU

**For Gas Balloons Model NL-STU**

**Issue 1 – Revision 7**

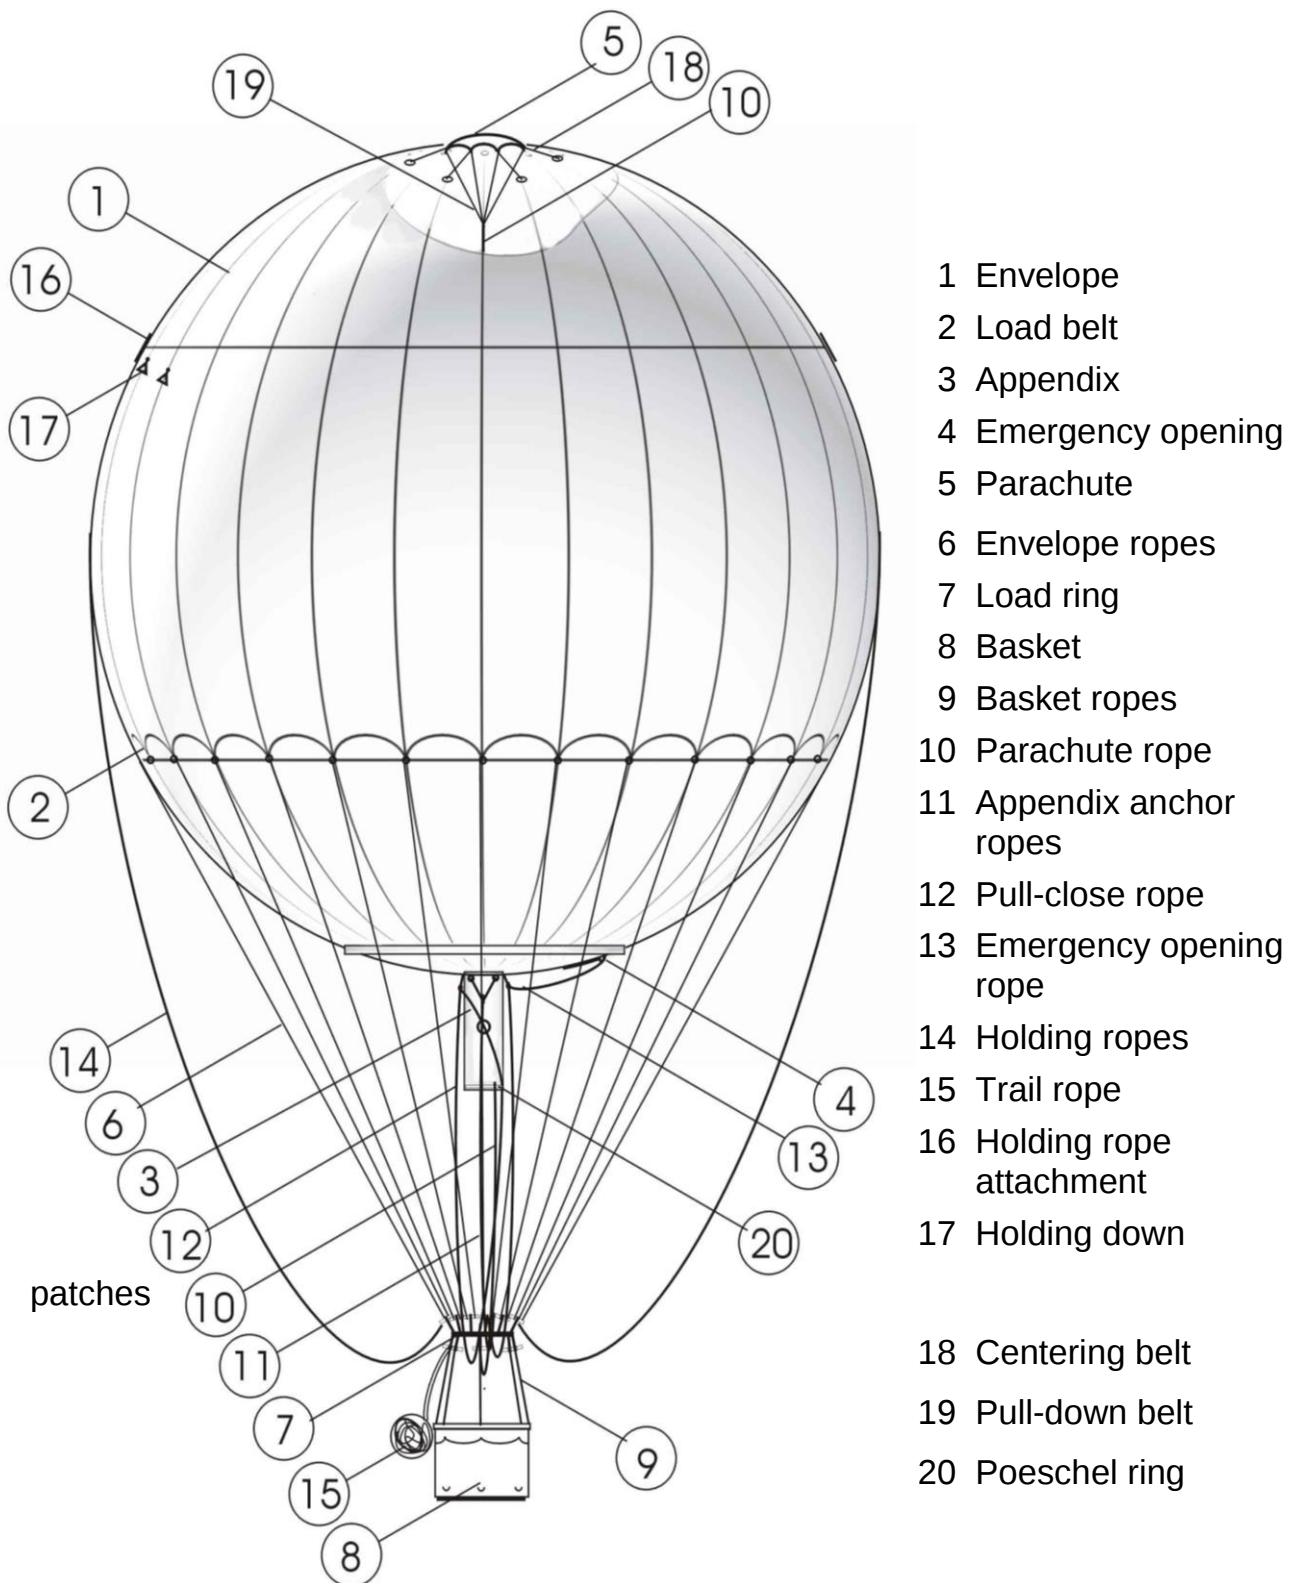
## 1.1 Description of the balloon system

### **1.1.1 Envelope**

The envelope material consists of a layer of nylon fabric with rip-stop threads. On the inside and outside it is coated with artificial caoutchouc or with polyurethane. The inside coating is electrostatic conductive in order to distribute electrostatic charges uniformly over the whole envelope. The surface resistance is maximally  $10^9$  Ohm at the inside. Coatings of different colors are used for the outside.

The deflation opening is located at the North Pole of the envelope, where it is sealed with a parachute. The edge of the deflation opening is protected against tearing in by a bolt rope made of stainless steel or Kevlar and is reinforced with several layers of fabric. The parachute is held in its correct position by means of centering belts. The parachute is pulled down for deflating of the balloon with the pull-down belts. The parachute also is used as a maneuvering vent.

The load belt is attached to the envelope at half the height between the equator and the appendix. It consists of belt bows that end in stainless-steel rings. The belt bows serve for introducing the load from the envelope ropes uniformly into the envelope. The envelope ropes that lead to the load ring are hooked into the stainless steel rings.

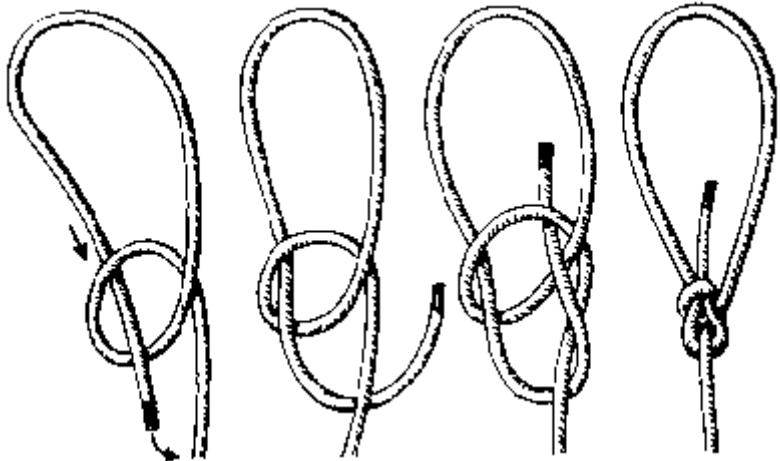
| <b>3. Appendix pull-close rope</b> | <p>Disconnect one end of the rope at the Poeschel-ring and link it to the new rope. Pull the new rope by use of the old rope along the way through eyelet and thimble and attach both ends of the new rope at the same position at the Poeschel-ring as it was before. Use the bowline-knot as shown hereafter.</p> <p style="text-align: center;"><b>bowline</b></p> |

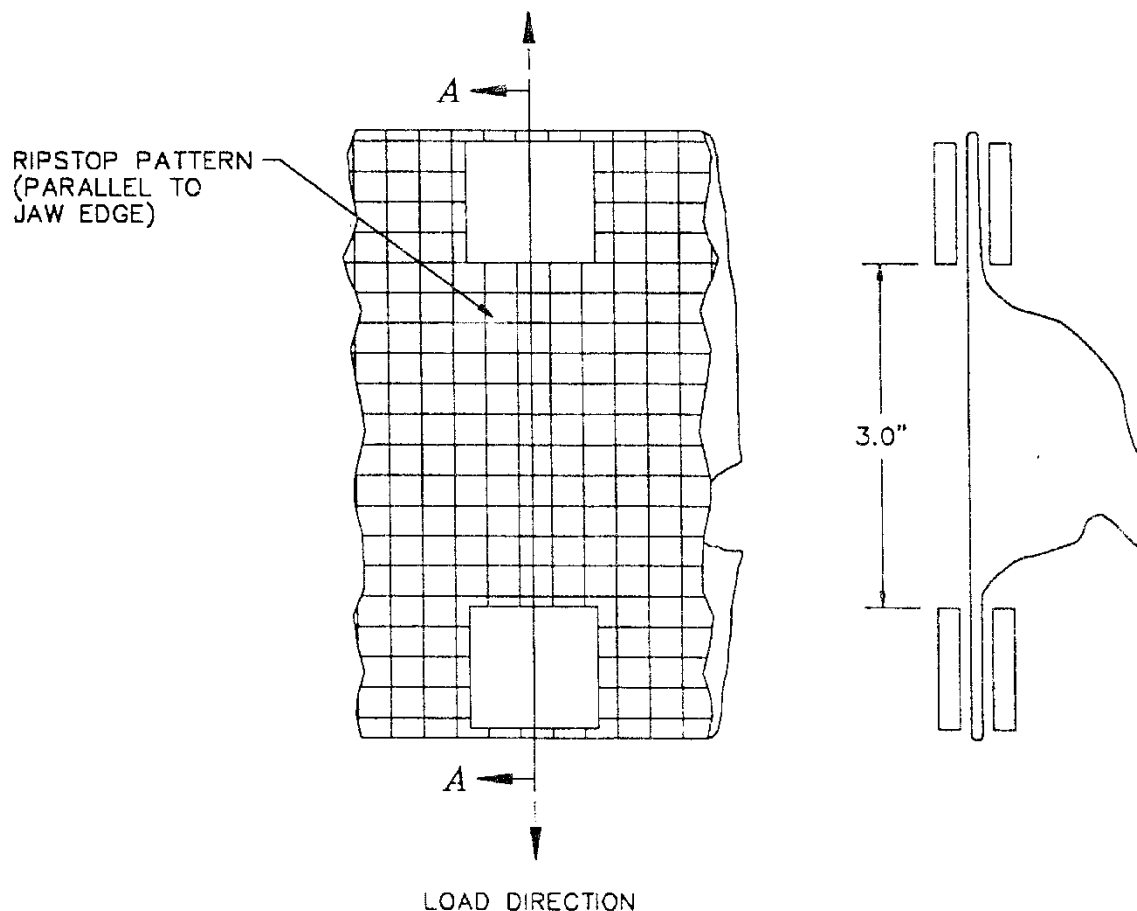
The balloon fabric should be gripped as shown below. Using the rip stop weave pattern as a guide, the jaws should be positioned so that the same yarns, in the test direction, are gripped by both pairs of jaws. The distance between the clamps should be 75 mm or 3".

The Grab test should be accomplished by gripping the test gauge and applying a smooth, uniform pull force in the test direction. Care should be taken to insure that the force is in line.

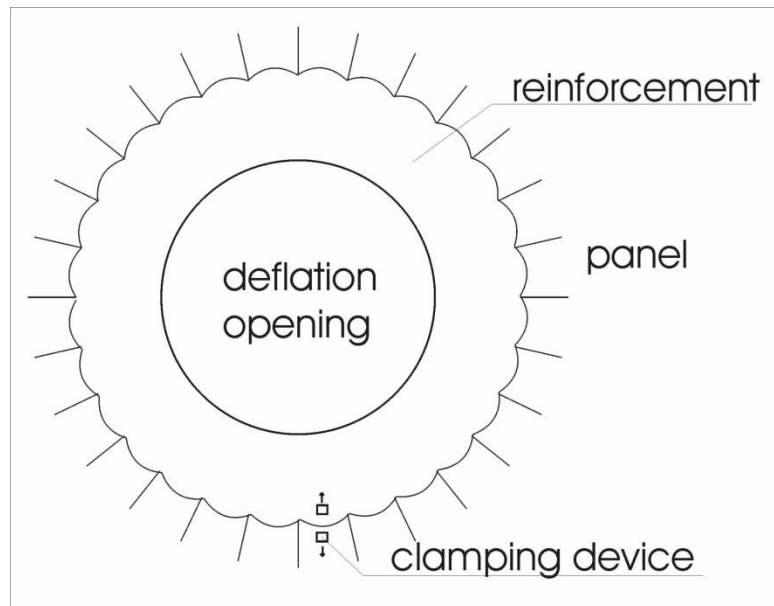
### **I. Deflation Opening**

3 times in different panels rectangular to the edge of the reinforcement of the pole. The distance of both clamping devices to the edge of reinforcement should be 30 mm (1.2").

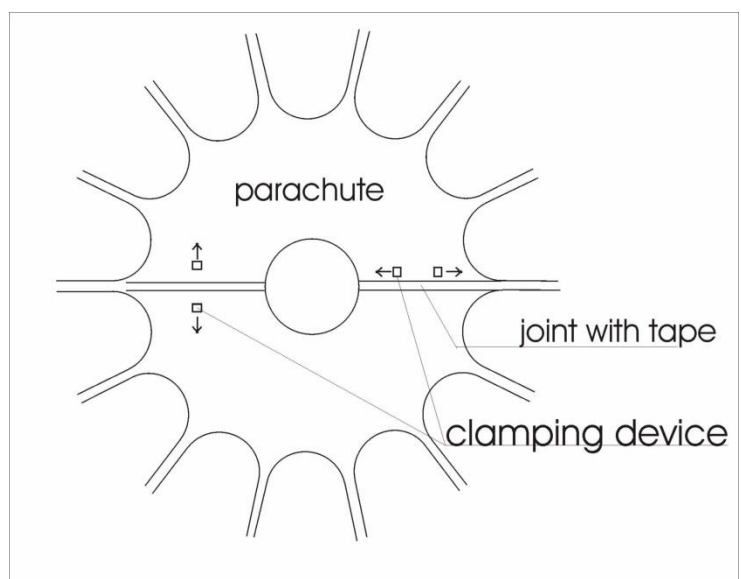
### **II. Parachute**

1 time across the joint. The distance of the clamping devices to the inside tape of the joint should be 30 mm (1.2").

1 time parallel to the joint. The distance of the clamping devices parallel to the joint should be 30 mm (1.2").

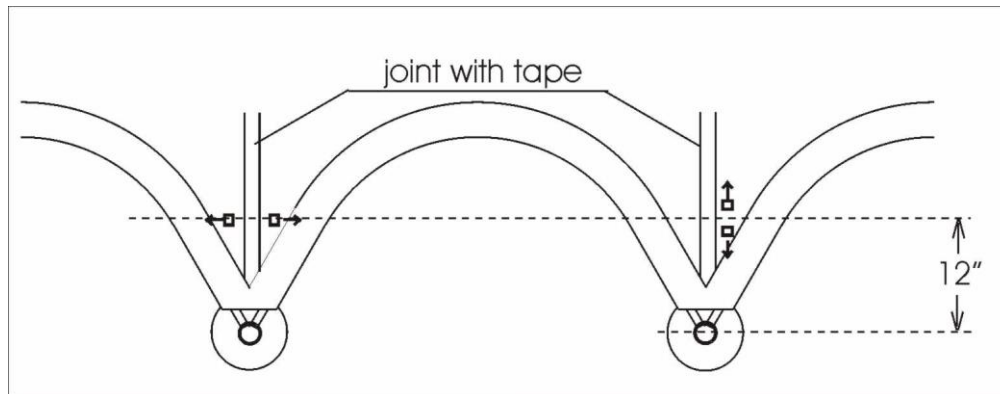
**III. Load belt**

3 times with a distance of 30 mm (1.2") parallel to the joints within a distance of 30 cm (12") over the stainless steel ring.

3 times across the joints within a distance of 30 cm (12") over the stainless steel ring. The distance of both clamping devices to the tape of the joint should be 30 mm (1.2").

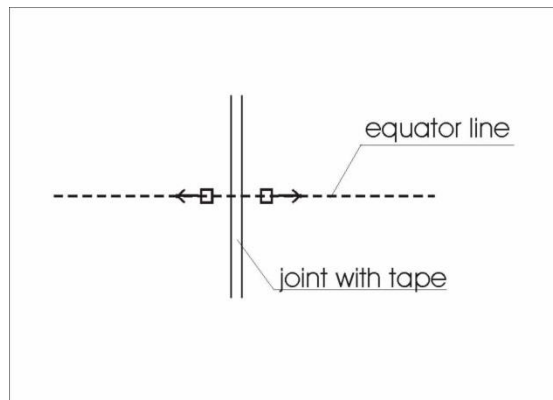
**IV. Equator:**

3 times across different joints. The distance of the clamping devices to the tapes of the joint should be 30 mm (1.2").
